New Zealand experiences in site clean up – the value of monitoring

Roper-Gee, R., Gilbert, N., Tangaere, J. Antarctica New Zealand

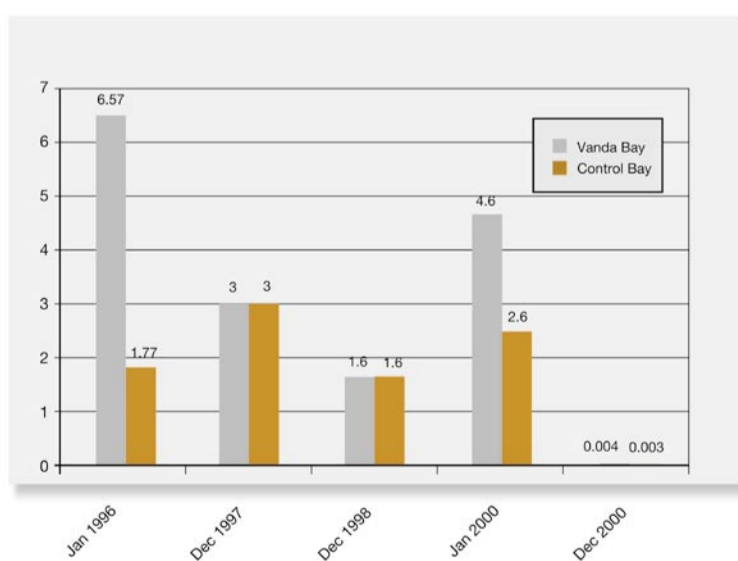
Figure 1: Example of Vanda monitoring data – zinc in surface water. Zinc was the only heavy metal species to show higher concentrations in Vanda Bay than Control Bay. During the period of monitoring zinc concentrations have reduced at Vanda Bay, to be almost identical to Control Bay.

From the station's removal in 1994/1995 until 2001/2002, water and algae samples were taken annually from Vanda Bay (immediately adjacent to the station site) and a control site for monitoring purposes. In 1996 samples were also taken from a pond which formed in “Greywater Gully”, the main liquid waste disposal site, which has not since reformed. Analysis undertaken by NIWA (the National Institute for Water and Atmospheric Research) included dissolved nutrients, chlorophyll, particulate nutrients, algal species composition and heavy metals. From the data collected it was concluded:

“There is no evidence, to date, to suggest contamination has occurred in Vanda Bay. Any contamination of the lake is at concentrations not detectable over background levels. ... This dataset provides a robust baseline that conveys the inherent variability in the environmental parameters being measured. An understanding of this variability will allow changes to contamination to be identified at an early stage, should inundation of Greywater Gully occur.” (Sutherland, 2002).

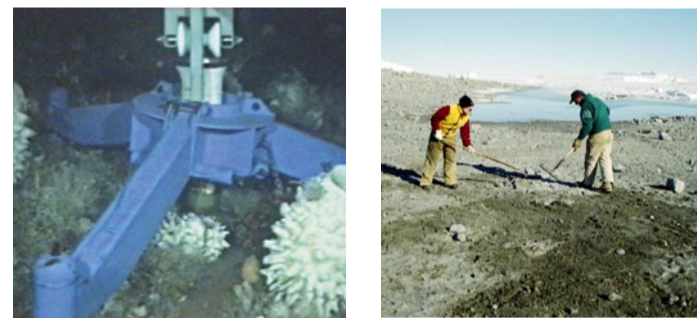
Figure 2: Left: An image taken from video monitoring of the first season of drilling, showing the sea riser guide base amongst siliceous sponges, a sea floor silica needle sponge mat and other benthic organisms. (Waterhouse, 2001). Right: Cape Roberts Project Manager and Camp Assistant raking to loosen compacted soil.

- total petroleum hydrocarbon analysis of soil and water
- visual monitoring of waste dispersal using underwater video camera
- visual monitoring of benthic communities at drill sites using underwater video camera
- visual assessment of disturbance to terrestrial environment
- skua population surveys.

Acceptable limits were set for all parameters (except skua numbers, due to high natural variability) and were not exceeded. Planned remediation was undertaken after removal of equipment, including litter picking and a novel approach to soil compacted by vehicles and storage, which was loosened by raking. After a winter the compacted areas were impossible to identify. Today almost no signs of the project remain.

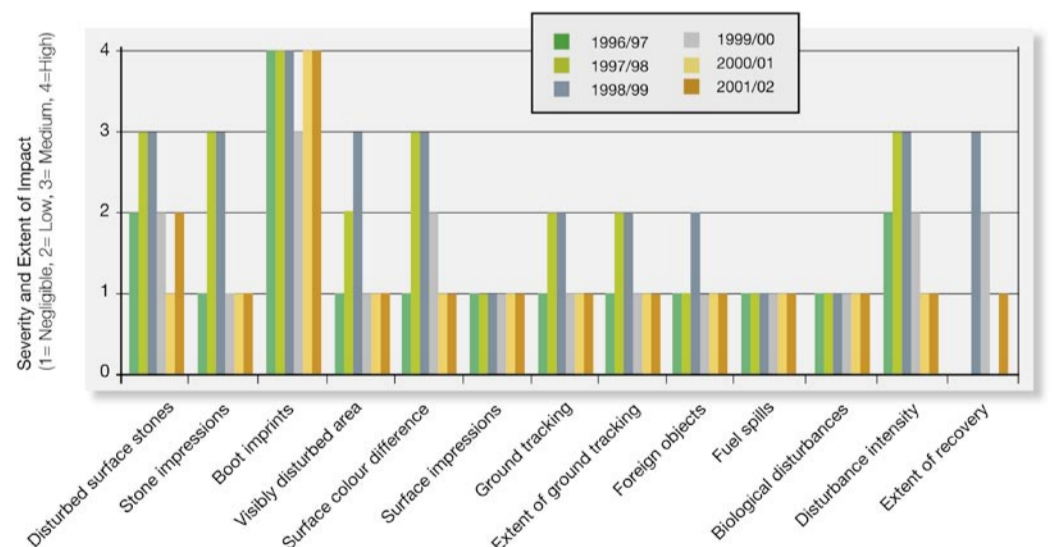
Figure 3: Example of visual assessment of terrestrial impacts – results for the Northern Plot (outside the storage area at Cape Roberts).
