# **Independent Environmental Audit of ANDRILL McMurdo Sound Portfolio Project**

**Phillip Tracey, Policy Advisor, Australian Antarctic Division**

**Rod Downie, Environmental Manager, British Antarctic Survey**

## ***Executive Summary***

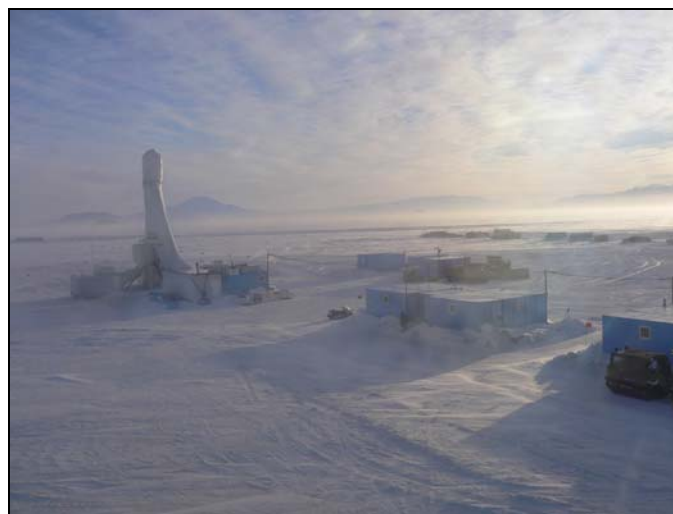
*Figure 1. ANDRILL SMS drill site on fast ice*

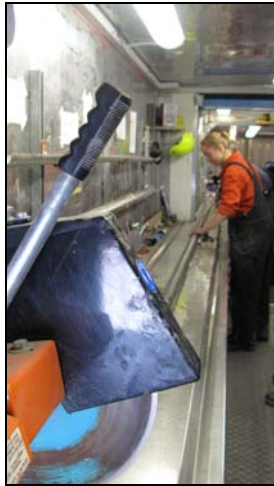
*Figure 2. Cleaning and initial description of core at ANDRILL SMS site laboratory*

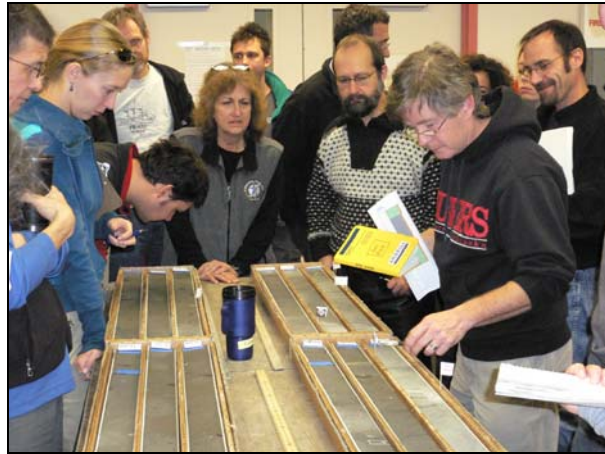
*Figure 3. Core tour and initial sample selection – Crary Laboratory, McMurdo Station*

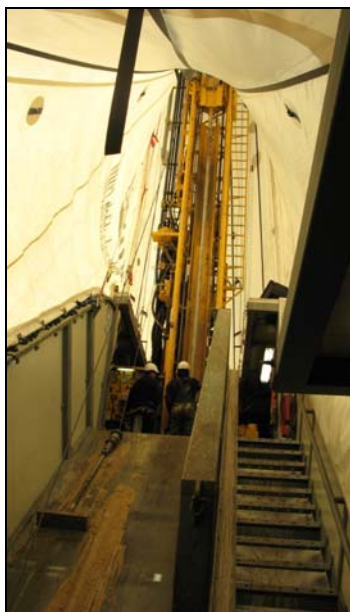
The ANDRILL rig is hydraulically powered from a separated diesel hydraulic power pack with hydraulic umbilical hoses feeding the winches, drill mast and rotary top head drive. The drill mast and platform are enclosed in a synthetic fabric shroud, designed to provide a warmer environment, and to enclose any hydraulic fluid spills from the hoses servicing the drill-head hydraulic power unit. A control box was mounted to the side of the drill platform, housing control, monitoring and logging equipment for the drill operation. The sides and underside of the drill rig were enclosed in synthetic fabric to direct and capture any fluid spills.

*Figure 4. ANDRILL rig*

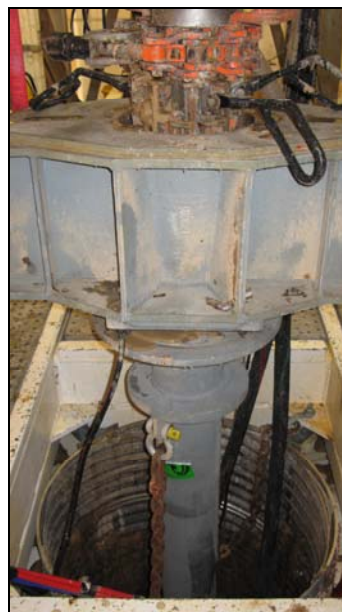
The drilling process involved making a hole through the ice-shelf or fast ice (using a hot water drill), and placing a casing ('sea-riser') through the water column and into the sea floor. A diamond coring bit, mounted on the end of hollow drill rod is deployed through the sea riser, and driven by the rotating drill rod to cut cores. Sections of core are removed from within the drill rod in a coring barrel. The rod progressively 'cases' the hole as coring proceeds and additional lengths of rod are added at the surface. Drill fluid is used to cool and lubricate the drill bit, return drill cuttings (rock and sediment waste) to the surface, and equalise the pressure inside the hole with the sub-surface pressures to prevent the hole collapsing inwards. The fluid is pumped down the drill rod, and circulates back to the surface during the drilling operation.

*Figure 5. Borehole – top of sea riser*

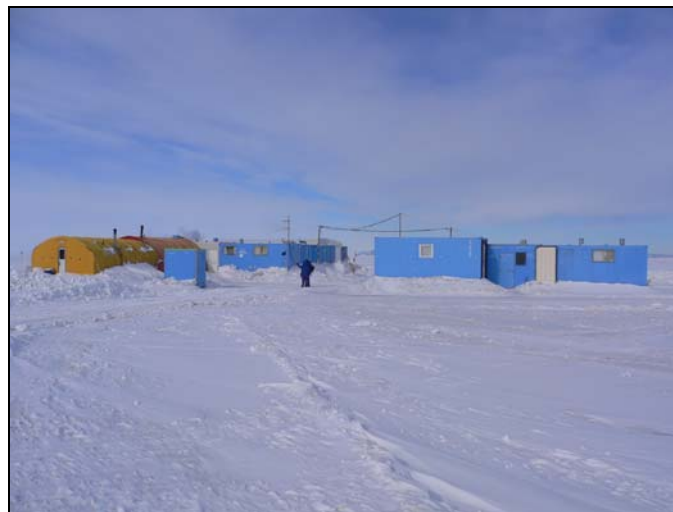
*Figure 8. ANDRILL accommodation camp*

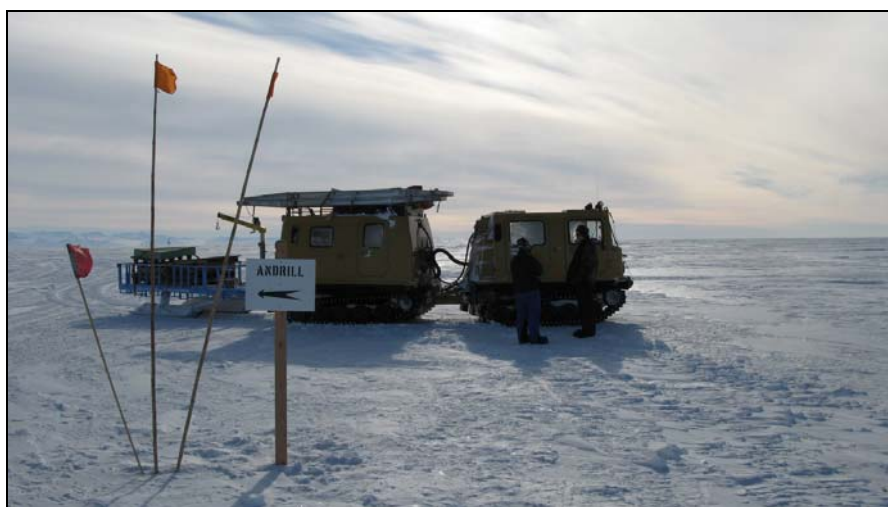
During the MIS drilling season, drilling teams were transported from Scott Base to the drill site by oversnow vehicle for each shift. Cores were transported to the Crary laboratory the same way. For the SMS site, helicopter flights were used to transport cores. Hagglund oversnow vehicles and skidoos were used for general transport and for personnel movements. Routes across fast ice and the McMurdo Ice Shelf, as well as local routes at the drill site were marked with flags. A small tracked loader was used around the drill site. A D6 bulldozer was on site and was used for refuelling operations, snow clearing, and moving heavy equipment. All surface transport was on snow and ice, except where using formed roads in the Scott Base and McMurdo Station areas.

*Figure 9. Flagged route to ANDRILL SMS site*

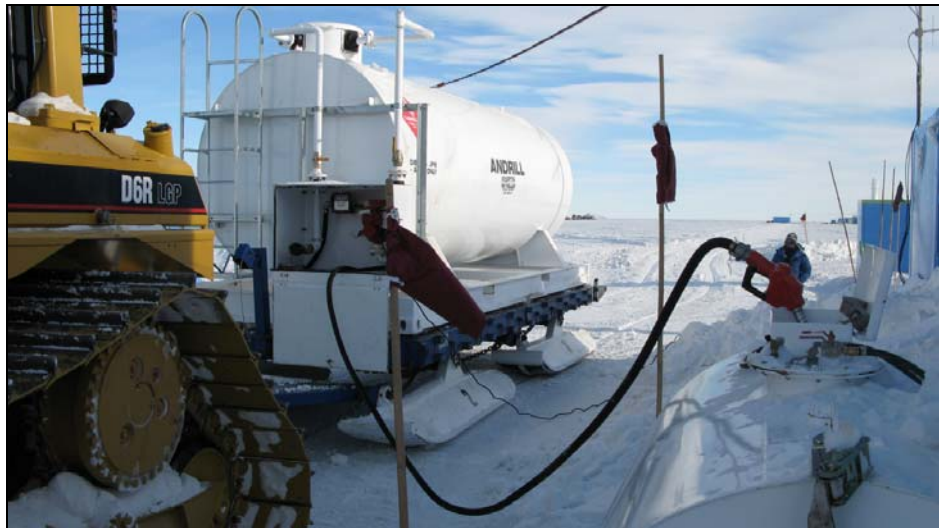
Bulk fuel was stored in two double skinned 15,000 litre sledge mounted fuel tanks. Two 2000 litre self bunded sledge mounted tanks were located at the drill site, and a third at the camp. A 1000 litre fuel tank and a 650 litre hydraulic oil tank supplied the drill rig powerpack, located inside a shipping container adjacent to the rig. Both were understood to be double skinned. The floor of the drill platform itself was lined with an impermeable sheet designed to catch spills. A 1000 litre diesel tank for a small heater was located outside the camp accommodation, fitted with an impermeable bund. This bund appeared to be well managed and little snow accumulation within the bund was witnessed. Drums of petrol/gasoline were stored on a raised sledge lined with a tarpaulin to collect fuel in the event of a spill.

*Figure 10. Refuelling from bulk to day tanks at ANDRILL SMS site*

Whilst recognising the experienced nature of the personnel on site, the team also noted the absence of documented fuel handling policy or procedures, which the CEE stated would be implemented. Transfer of fuel from bulk tanks to day tanks was observed during the site visit. This was carried out by a single operator, who remained inside the cab of the vehicle for part of the time during refuelling.

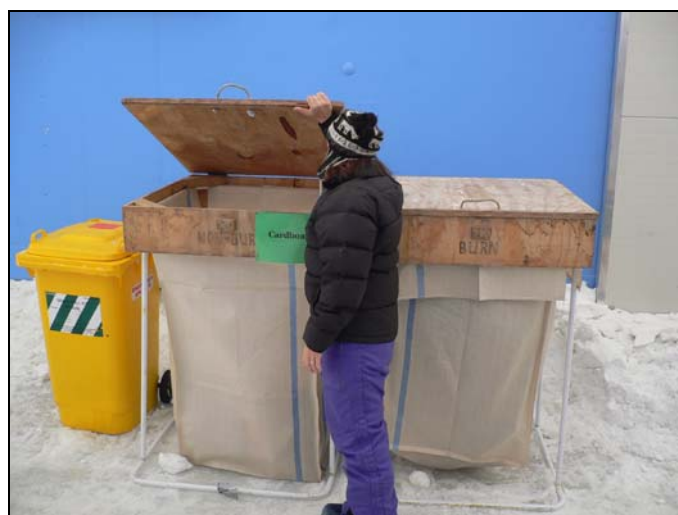
Waste generated at ANDRILL was separated at source according to the waste management system in operation at Scott Base, and sent to the station with returning vehicles. Storage on site was short term and there was little accumulated waste. Waste oils and lubricants were stored inside an ISO container. General and recyclable waste was stored in an enclosed and covered porch at the main camp, thereby eliminating the risk of its dispersal into the environment.

*Figure 11 ANZ Environmental Officer inspecting waste segregation at ANDRILL SMS site*
